**Flood Control Project Maintenance  
Levee Inspections****LMA District Cover Sheet****Spring 2011 Levee Inspection Results****Sacramento Maintenance Yard Sacramento Bypass**

**Levee Inspection Report By Mile - Spring 2011**

**Sacramento Maintenance Yard Sacramento Bypass**

Waterway	Bank	Unit Miles	Inspection Start/End	Inspector
Unit No. 01 Sacramento Bypass or North Levee	Right	1.73	03/08/2011 03/08/2011	John Williamson

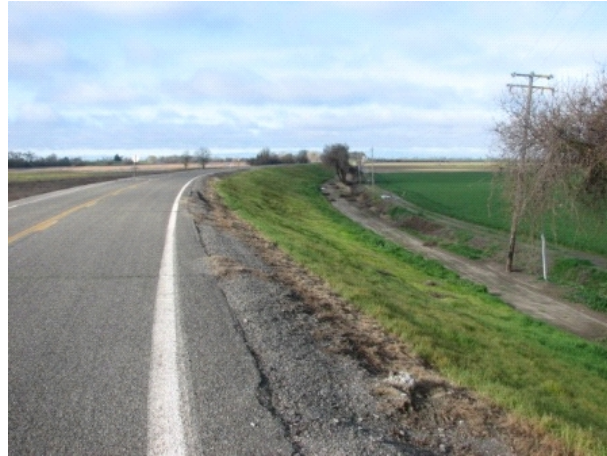
johngw\_s\_20110309\_346.jpg

Levee Mile Report Line	1
Start Levee Mile	0.04
End Levee Mile	0.04
Location	Land Side
Category	Earthen Levee
Item	Vegetation

This is a photo of the grasses on the landside of unit 1.

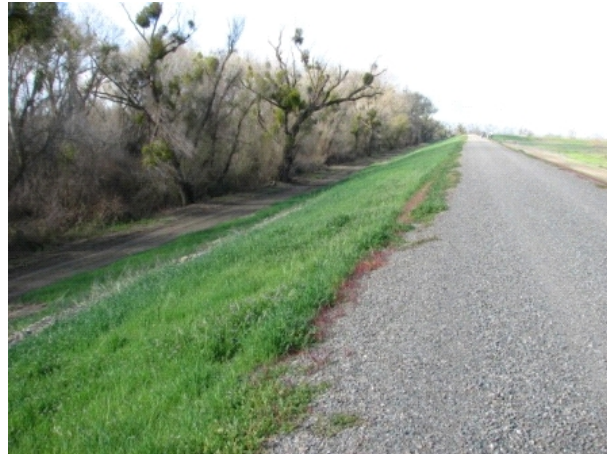
johngw\_s\_20110309\_347.jpg

Levee Mile Report Line	2
Start Levee Mile	0.46
End Levee Mile	0.46
Location	Water Side
Category	Earthen Levee
Item	Vegetation

A photo of the waterside slope with well maintained grasses.

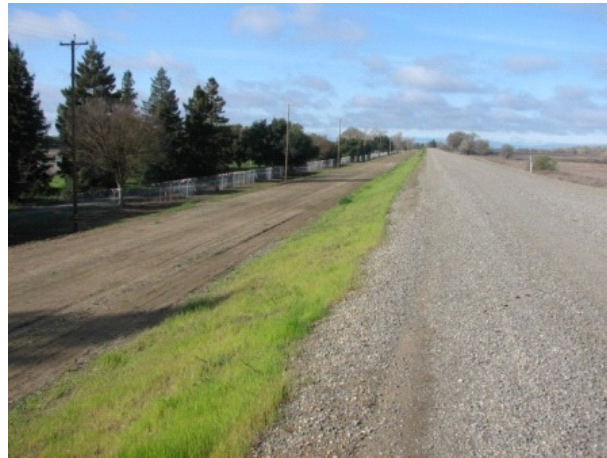
johngw\_s\_20110309\_348.jpg

Levee Mile Report Line	1
Start Levee Mile	0.05
End Levee Mile	0.05
Location	Land Side
Category	Earthen Levee
Item	Vegetation

Landside slope of unit 2 with good maintenance of grass and stability berm.

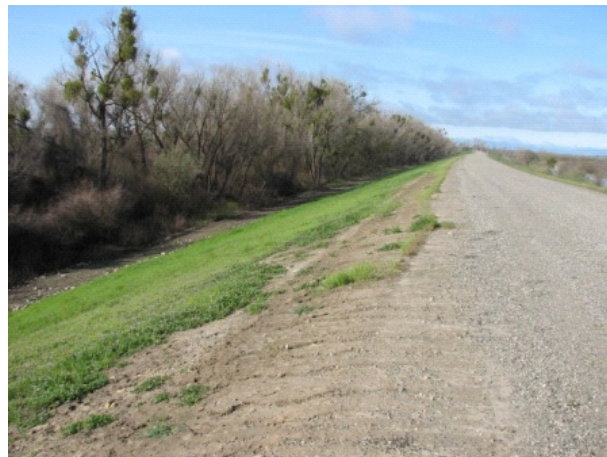
johngw\_s\_20110309\_349.jpg

Levee Mile Report Line	2
Start Levee Mile	1.26
End Levee Mile	1.26
Location	Water Side
Category	Earthen Levee
Item	Vegetation

Grasses on the waterside slope of unit 2.

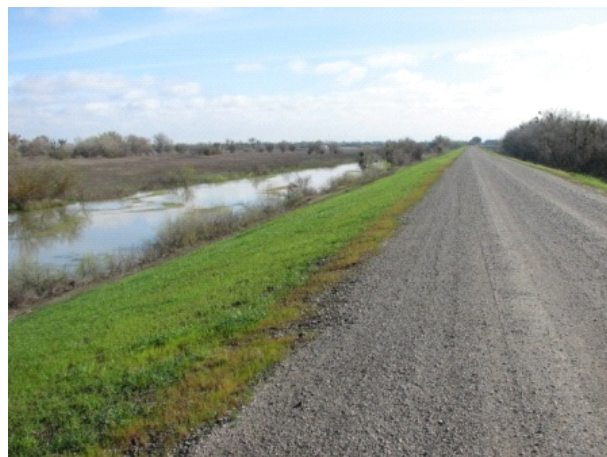
johngw\_s\_20110309\_350.jpg

Levee Mile Report Line	2
Start Levee Mile	1.26
End Levee Mile	1.26
Location	Water Side
Category	Earthen Levee
Item	Vegetation

Waterside slope is on both sides of the levee from L.M. 1.26 to the end.
